Subject: Pre-Blasting Survey of the Swapp and Sorenson Ranch; Alton Coal Development LLC,
Coal Hollow Mine, C/025/0005

PRE-BLASTING SURVEY
SORENSEN RANCH
FOR
ALTON COAL DEVELOPMENT, LLC
COAL HOLLOW MINE

BY
DAN W. GUY, P.E.
AUGUST 2, 2011

SORENSEN RANCH

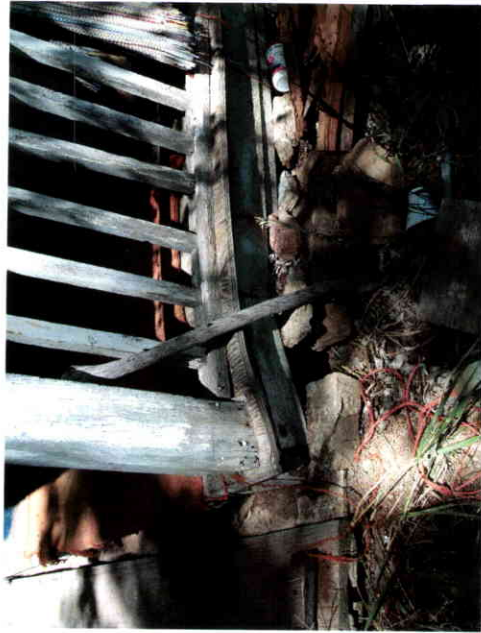
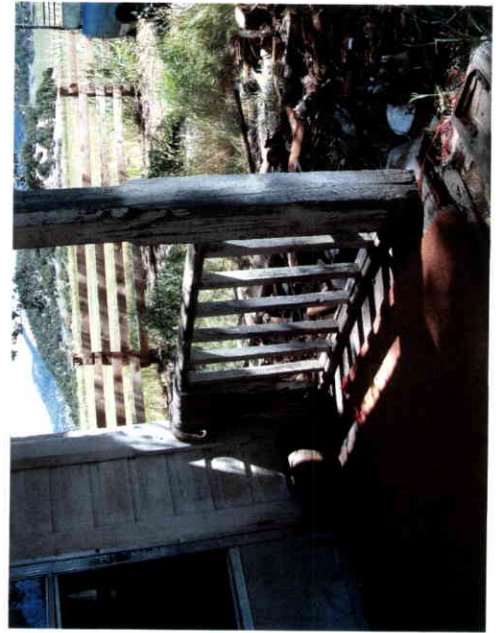
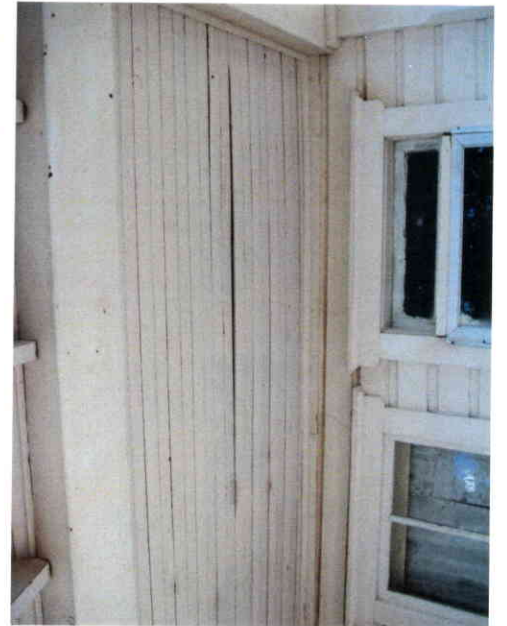
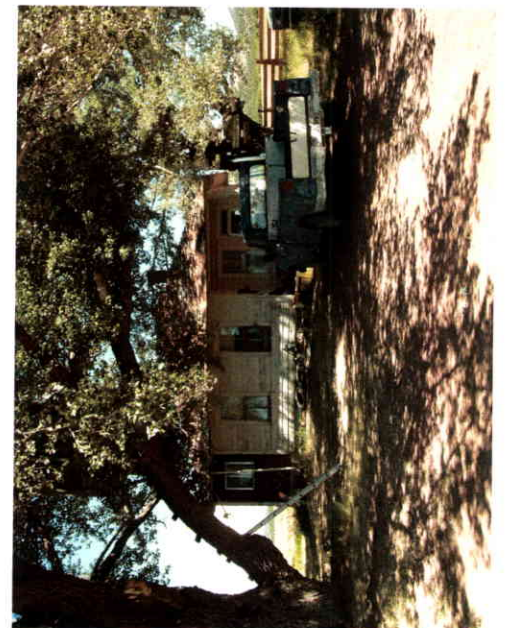
PLATE 3

Estimating the condition of a 100+ year-old house is very subjective. Compared to a newer, modern house, the condition may be considered poor; however, for a house of this age, I would consider it in fair to good condition. The house appears to have very little damage, except for wear on the floors and some sagging on the porch and steps. There were no broken windows observed during this survey. Because the interior walls and ceilings are mostly tin, the photos show some gaps at the overlap of the materials. There are some wall and ceiling areas where some "waving" is evident, but it doesn't appear to be actual damage or separation of the materials. Numerous photos were taken of both the interior and exterior of the ranch house. These are shown on Plates 3 through 13 of this report. The photos will provide the best assessment of the existing condition of the structure.

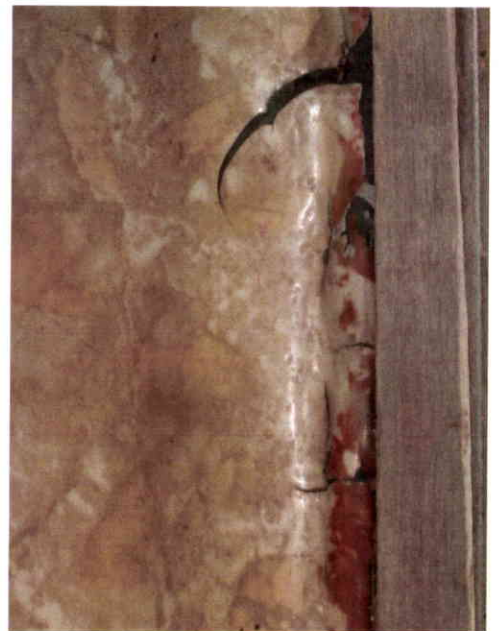
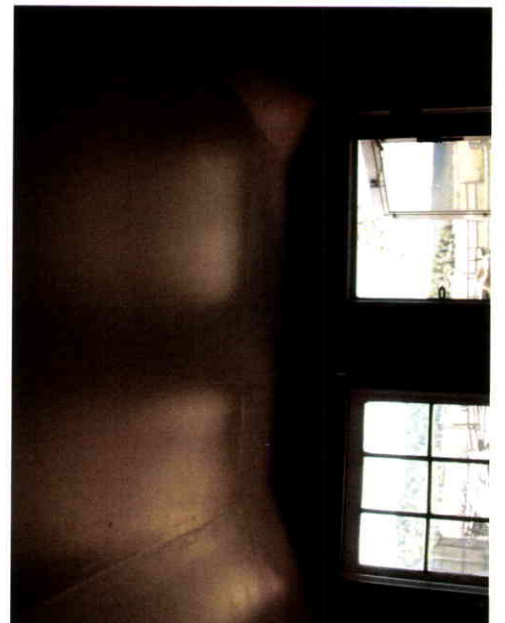
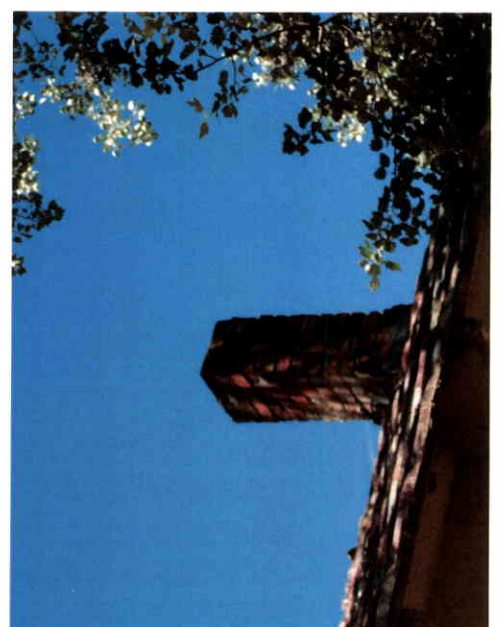
PLATE 14

Guest House – The guest house is wood construction inside and out, and sits on a plank on rock foundation as shown on Plate 14. The interior has paneled walls, linoleum floor and sheetrock ceiling. The owner said it was a motel cabin that has been moved onto the site. The house has no plumbing or power. It does have a wood/coal stove, three multi-pane windows and a newer aluminum storm door.

The interior of the guest house is in relatively good condition. The only existing damage noted inside is some cracking in the linoleum flooring at a seam and near the doorway. The exterior of the structure is mostly unfinished, rough wood. One area of concern is some of the vertical plank foundation supports are shifting, leaving some potential for future settling. The interior and exterior views of the guest house, along with photos of the areas described above, are shown on Plates 14 and 15.

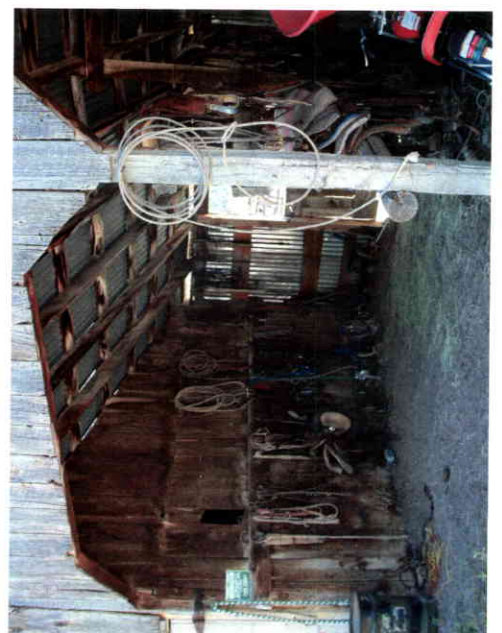
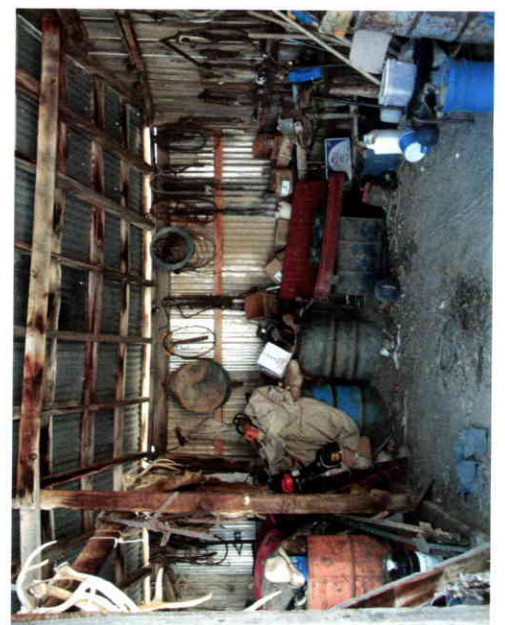
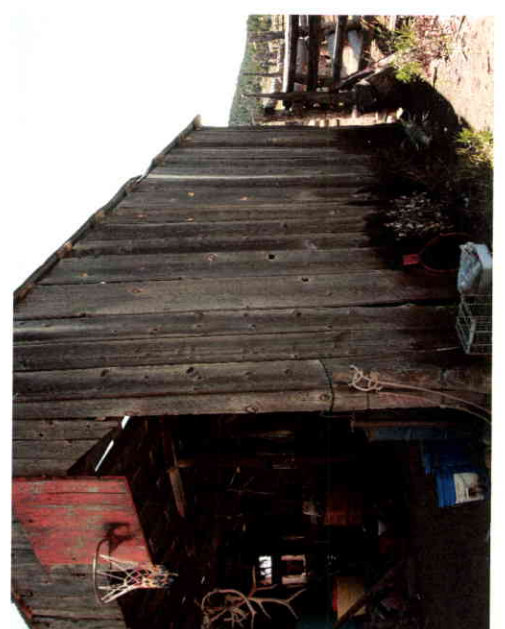
PLATE 16

The building is obviously quite old. It does appear to be of substantial construction, and according to the owner, has withstood large

accumulations of snow with no serious damage. It does show signs of extreme weathering, but no structural failure. The condition is best determined by the photos in Plates 16 and 17.

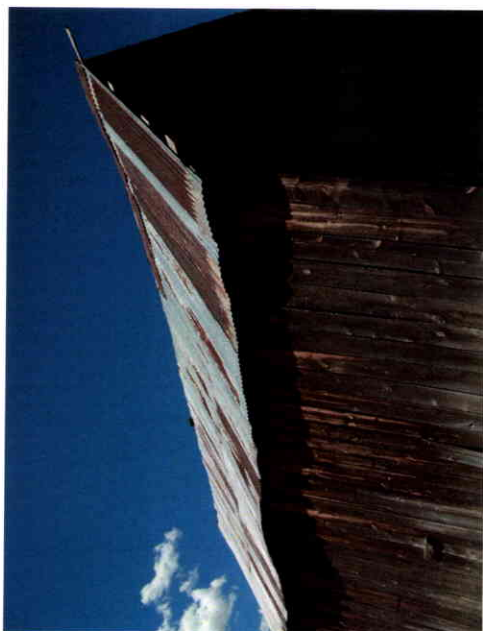
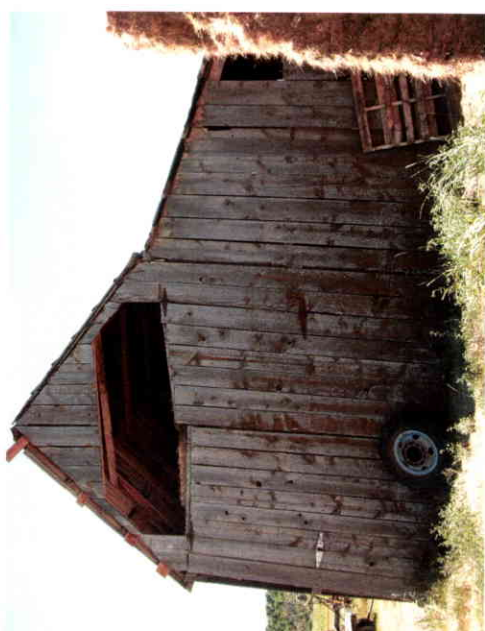
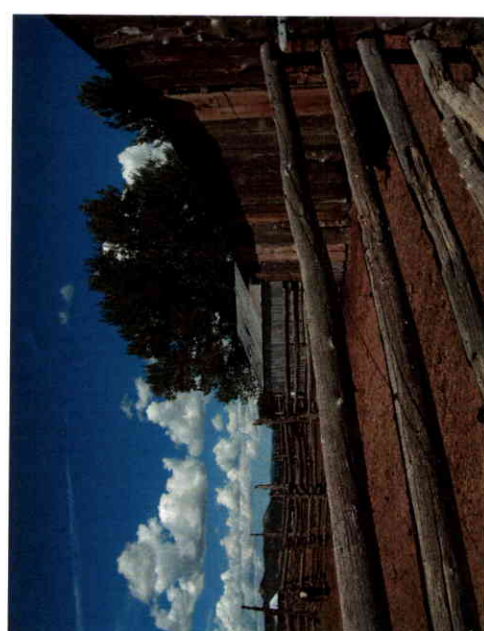
PLATE 18

Barn – This structure is also wood construction with a dirt floor and no foundation. It does have a galvanized tin roof. As with the adjacent shed / garage, it shows a considerable amount of age and weathering. It also appears to be of substantial construction, and although there are a number of gaps in the wood siding and some slumping of the large doors, there doesn't appear to be any structural failure. Photos of the barn are shown on Plate 18.

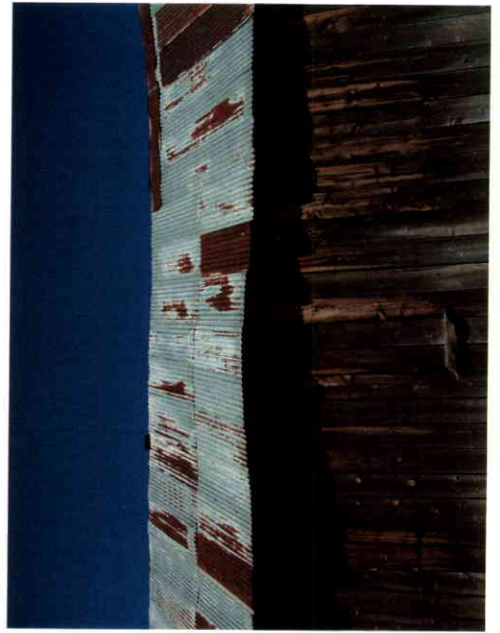
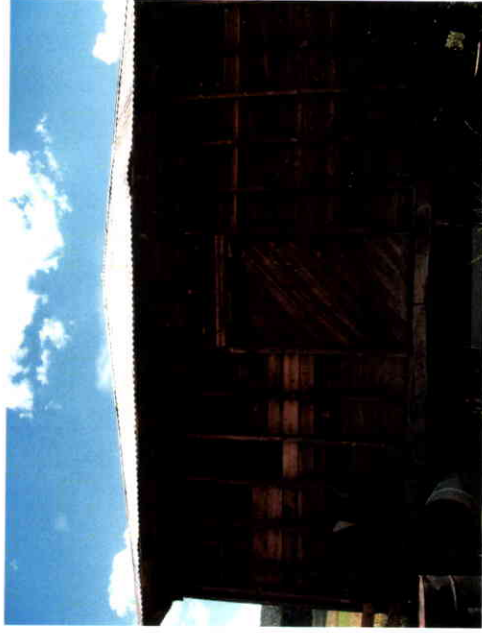
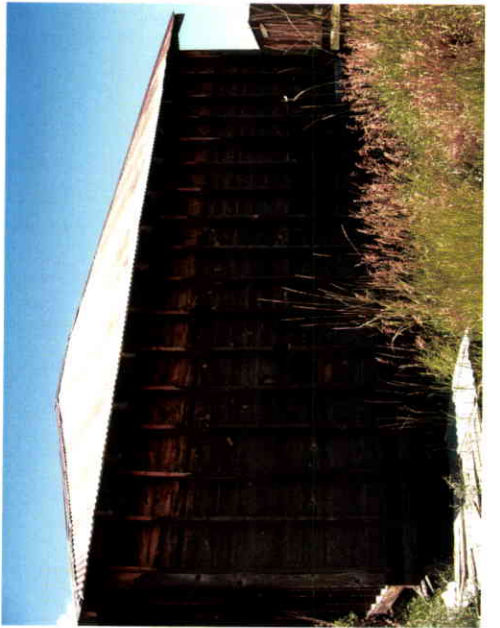
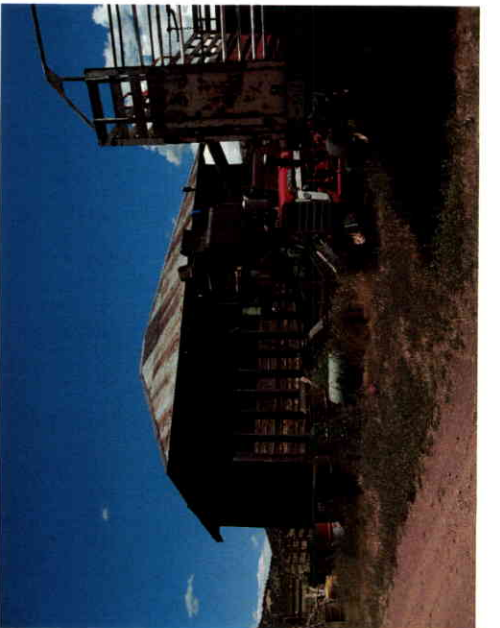
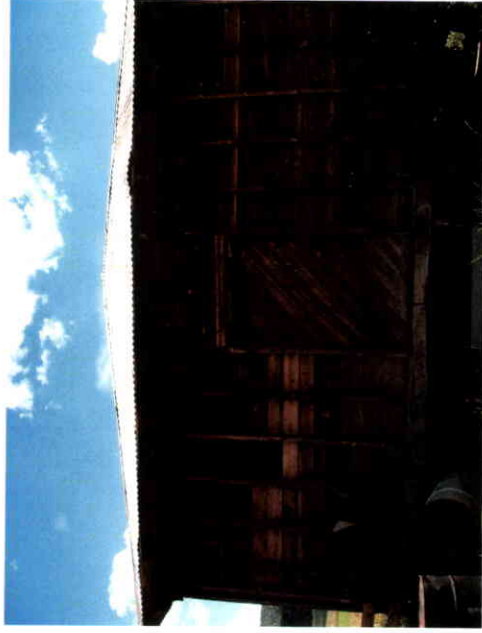
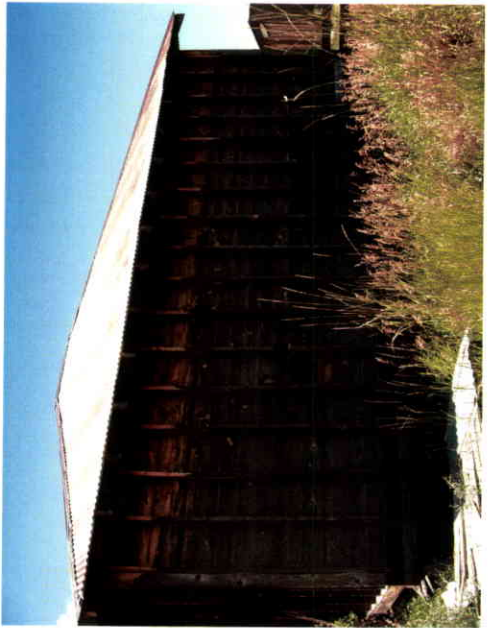
PLATE 19

Granary – The granary is located southeast of the ranch house, as shown on Plates 1 and 2. It is also of wood construction with no actual foundation, although the entire structure is elevated and sits on wood blocks. It has a wood floor and tin on the bottom of the building to keep out rodents. It appears to be well built and shows no sign of structural failure, although the exterior is extremely weathered. The elevated wood block supports do show some tilting in spots, but the building still appears level and stable at this time. Photos of the exterior of the granary are shown on Plates 19 and 20.

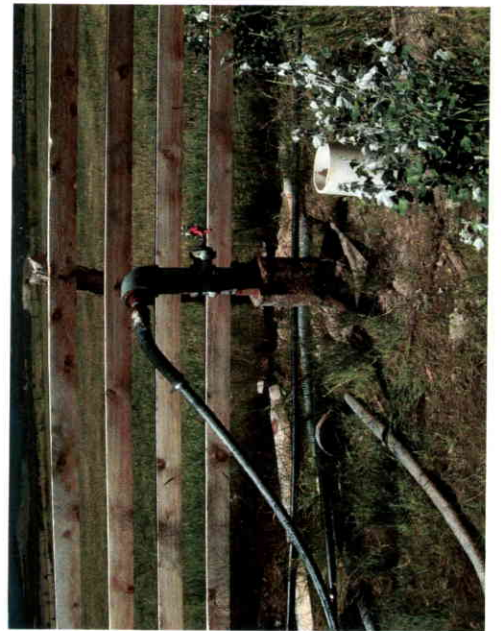
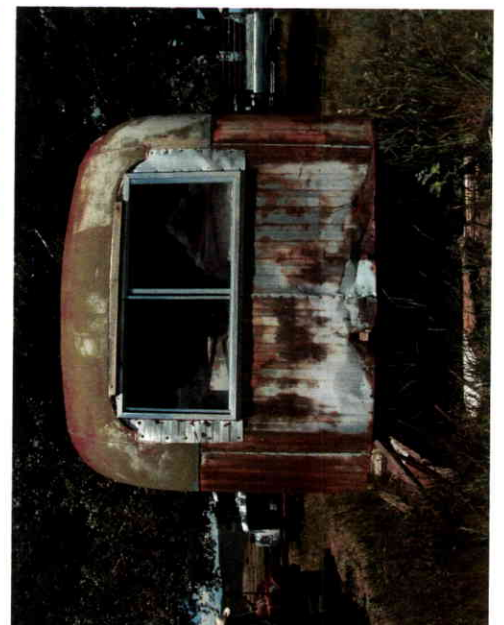
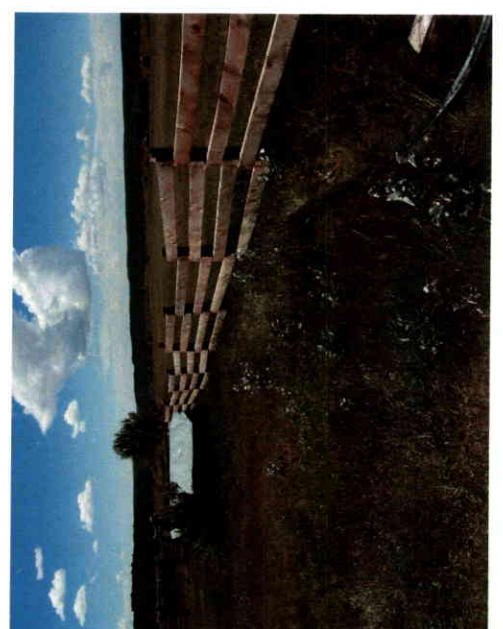
PLATE 21

Trailers – There are 2 trailers on the site. One is a newer mobile home, and was only documented in a photo. It is sitting on wheels, and has little, if any, potential for damage from blasting. The other trailer is an older 5th Wheel type trailer supported by steel drums and elsewhere by wooden blocks. The owner referred to this trailer as the "Motel". Once again, there is little, if any, potential for damage to this trailer from blasting. The condition of both trailers can be seen on Plate 21.

livestock on the site. It should be noted that this well is monitored on a regular basis by a hydrologist working for Alton Coal Development, LLC. Any damage or decrease in flow from this well would best be determined by the hydrologic monitoring. The exposed portion of the well is shown on Plate 21.
